TECHNICAL REPORT ARCCB-TR-00008

**EVIDENCE AGAINST HYDROGEN  
CRACKING IN GUN BORES: A REPLY**

**PAUL J. COTE**

**MAY 2000**

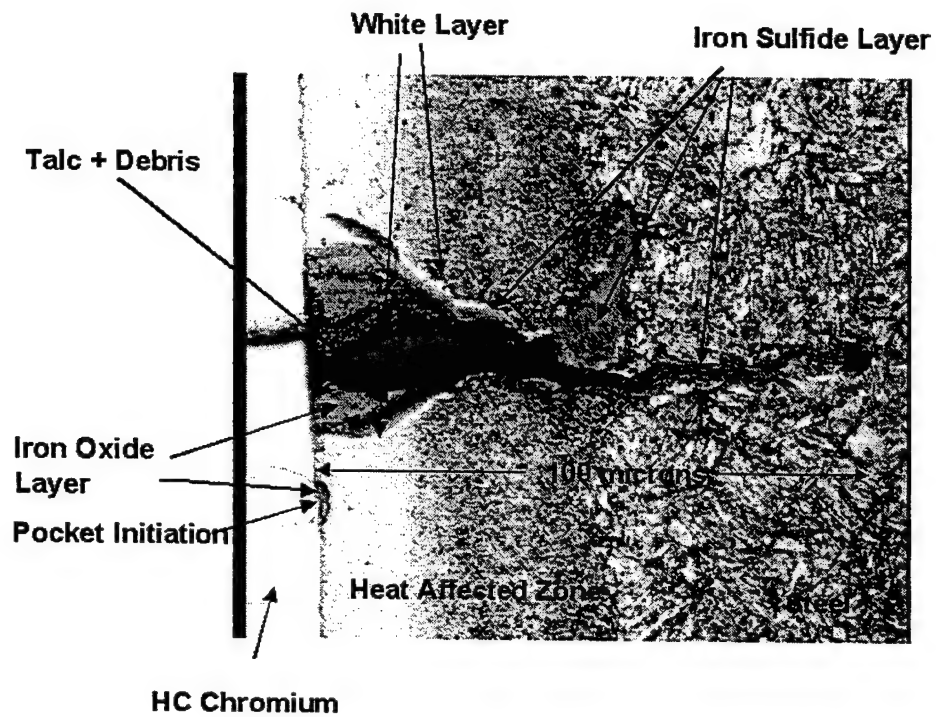
Because of the relatively isotropic nature of the corrosion at the chromium crack tips, and the relatively high volume of steel consumed at that site, it is concluded that fracture in uncorroded steel is not central to damage initiation beneath the chromium. The micrographs in Reference 1 offer straightforward illustrations of the dominant role of chemical attack. Figure 1 is reproduced from that report as an example. The image is from specimen 2, which is a tube that had experienced 220 conventional rounds and 80 experimental high-temperature rounds. The undermining of the chromium coating is clearly shown. Evidence of sulfur, oxygen, and carbon attack (white layer) are all present in this figure. The entire length of the extended erosion pit is coated with a gray layer (iron sulfide).

Finally, the specific issue here is our conclusion (ref 1) that the hydrogen-cracking mechanism proposed by Underwood and Parker (ref 4) is inconsistent with the observed progression of high-temperature corrosion into the steel at the chromium crack tips. Hydrogen cracking is expected to occur at or near room temperature and at atmospheric pressure. Thus, such cracks should be manifested as corrosion-free and debris-free narrow cracks. The proposed hydrogen-cracking mechanism involves interaction of the tensile stress layer (estimated at 500 microns deep), formed on cooling in the heat-affected layer of steel, with the hydrogen supplied by earlier exposure to the high-temperature propellant gas. The distinguishing feature of this proposed mechanism is that the hydrogen cracks ought to be substantially developed (several hundred microns deep) after the first few rounds since the stress layer and the hydrogen are both present after the first few rounds. Such rapid, early fracture is inconsistent with the general observations (ref 1) of relatively slow, gradual progression of corrosion damage into the steel (e.g., Figure 1).

The view (ref 2) that rapid fracture *must* play a role in propagation of damage into the steel is addressed next. It was suggested in Reference 1 that fracture through corroded grain boundaries or through mechanical fatigue and fracture (where there is no corrosion) can also contribute to damage propagation. Hydrogen cracking is considered unlikely, however, for the reasons cited above. It is not clear that fracture into uncorroded steel *must* play a role in the early stages of damage propagation, especially where corrosion rates are high. Consider the results in Figure 1, which has the deep corrosion pits with only 300 total rounds. Assuming the empirically-determined 0.4 micron per round rate of iron sulfide layer formation in propellant environments, and assuming a film rupture process with fresh metal exposure through the sulfide fissures with each firing, one estimates corrosion pit depths of 120 microns. (The estimate is conservative because it ignores the observed diffusion enrichment of the steel by sulfur beneath the scale (~0.3 micron per round)). The estimate is in accordance with the corrosion pit depth of 100 microns in Figure 1, so that rapid fracture of steel is not essential to explain the shape of extended corrosion pits.

Figure 1. Initiation and propagation of high-temperature corrosion into the gun bore surface beneath the chromium coating.

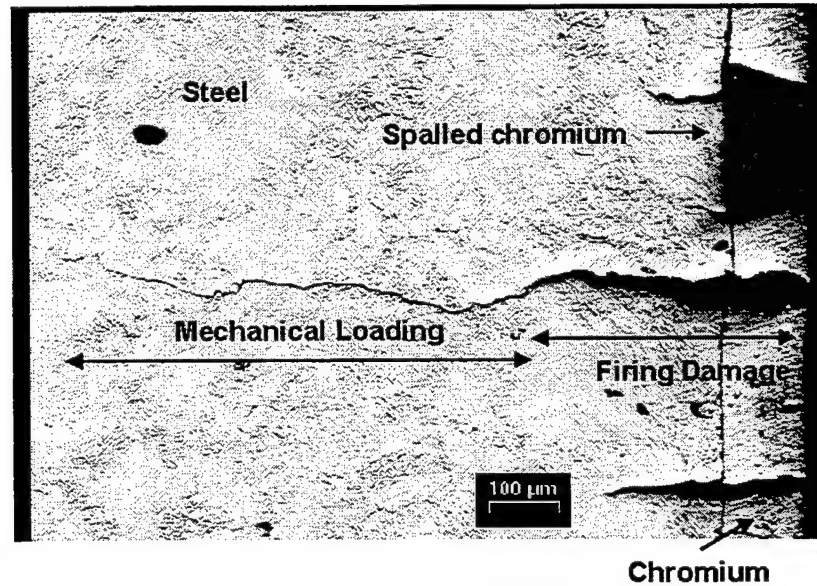
Given the reliance on a meandering crack shape and branching to establish hydrogen cracking, it is useful to examine the shape of fatigue cracks that are produced by pure mechanical loading in a simulated fatigue test using hydraulic pressure. Figure 2 shows results on a 120-mm specimen that had developed significant erosion pits by firing 1246 conventional rounds prior to mechanical testing, where 6593 cycles were applied at 97,600 psi. Hydraulic pressure cycling was applied to develop fatigue cracks for the purpose of establishing safe service lives of eroded tubes. In these specimens, such cracks are easily distinguished from those due to firing because of their narrow widths, long lengths, and absence of corrosion products and firing debris. It can be seen that the fatigue crack grown under purely mechanical cycling has all the features

attributed to classic hydrogen cracks. The longest crack in this specimen was approximately 1-cm in length and exhibits all the features associated with environmental cracking, including branching all the way to the crack tip. This is twenty times deeper than the estimated tensile stress zone (ref 3), so it cannot be attributed to the proposed hydrogen-cracking mechanism. The mean crack growth rate for this mechanically driven crack is over one micron per cycle. Thus, rapid cracking and crack shape are insufficient to establish hydrogen-cracking mechanisms in gun tubes. The usual mechanical fatigue cracks may easily be mistaken for hydrogen cracks with those criteria.

Figure 2 also shows a spalled section of chromium that is typical of what is observed in the survey study (ref 1). In general, the spallation is at or near the chromium/steel interface and as can be seen in this figure, there is no joining of cracks in the steel beneath the chromium.

Figure 2. Portion of the fatigue crack generated by mechanical loading seen to have the same meandering, branching nature usually attributed to classic hydrogen cracking.

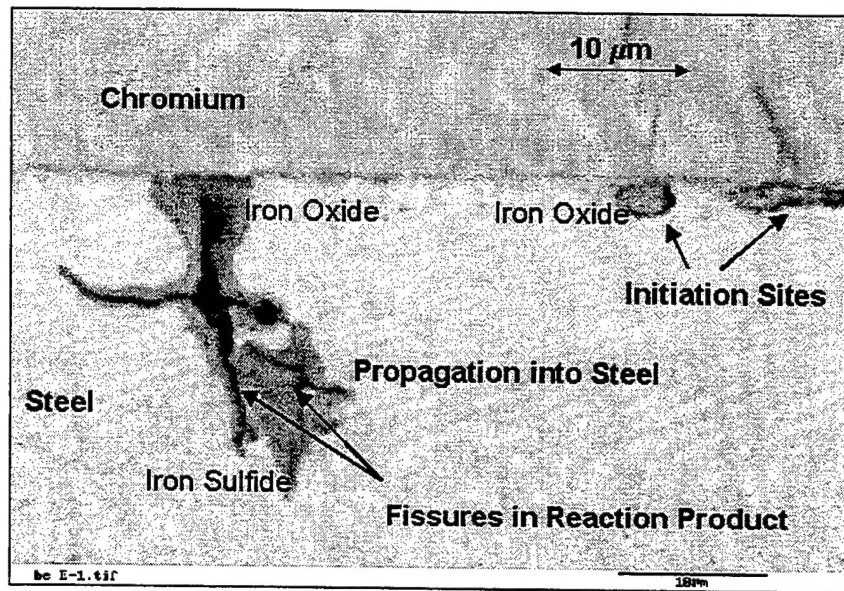
Figure 3 is a scanning electron micrograph (SEM) of typical reaction products that form at the tips of the cracks in the chromium coating for the same specimen as in Figure 1. The fractures in the SEM images are better defined than in optical micrographs. This is the typical result, which provides a straightforward illustration that fracture into uncorroded steel is not observed in early stages of damage. Thus, as illustrated by this figure and by the data in Reference 1, there is no evidence for the predicted incremental hydrogen cracks that are supposed to form at room temperature and pressure (according to the slow mode scenario) after the last round. The only observed fractures are in the form of fissures in the brittle reaction products (sulfides and oxides); these serve to direct the progress of the gas-metal attack into the steel.

Figure 3. SEM illustrating that fracture into uncorroded steel does not occur during initiation of damage beneath the chromium coating.

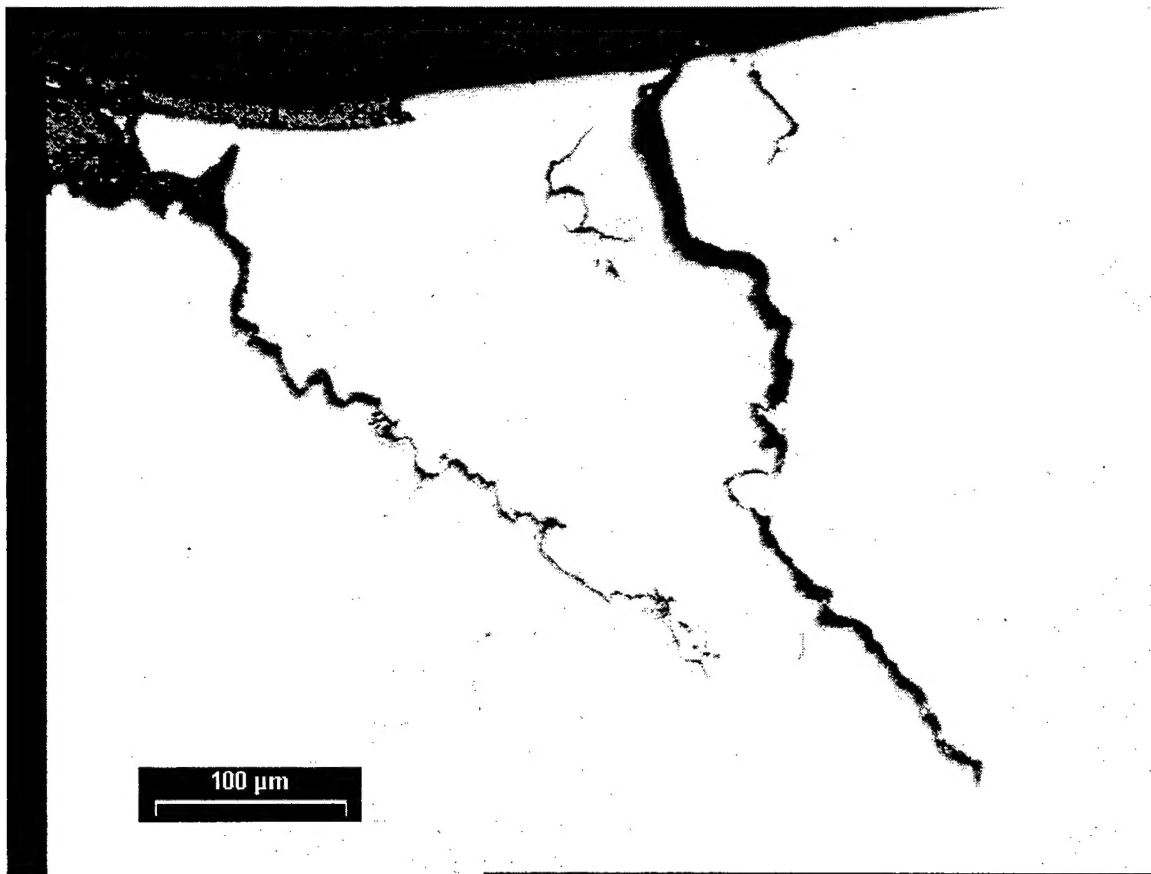
All earlier discussions focused on damage initiation. Figure 4 shows the opposite extreme, that is, several of the deepest fractures in specimen 2. These fractures occurred in a section where the chromium coating and several millimeters of steel had been eroded away. Cracks resembling the one at the left in the figure are used to show that hydrogen cracking may be present since it is assumed (ref 2) that mechanical fatigue alone cannot produce cracks of this length (in 300 rounds). As illustrated in Figure 2, however, this deep, branching, crack pattern is, in fact, consistent with mechanical cracking.

The majority of the deep cracks in this sample resemble the crack at the right in Figure 4 with its blunt crack tip. Crack blunting in deep cracks is probably not due to ductile fracture, since the irregular surface morphologies at the tips do not give the appearance of plastic flow. Regarding the hydrogen cracks that are supposed to form after each firing, one never observes the sharp debris-free hydrogen cracks emanating from any of the numerous blunt cracks in these specimens.

Another notable feature is the general widths of the cracks. Comparison of cracks in Figure 4 with the room-temperature cracks from mechanical loading in Figure 2 show crack widths are, in most cases, roughly a factor of five larger when produced under firing conditions. This suggests a high rate of material removal via gas-metal attack, even for deep cracks in fired tubes. While there are no observable reaction products (gray layers) in the steel at the tips of

these deep cracks, there is evidence of firing debris all along the cracks. For example, energy dispersive x-ray analysis shows aluminum deposited (from the projectiles) and potassium along the full length of even the deepest cracks, indicating exposure to hot gas attack at the crack tips.

Figure 4. Micrograph showing examples of the most severe fractures in specimen 2.
